Independent Vehicle Inspection Centre

## Case Study

<b>Vehicle:</b>	2011 Toyota Corolla
<b>Insured Value:</b>	\$12,000
<b>Market Value:</b>	\$6,000
<b>Ancap Safety Rating:</b>	3.5

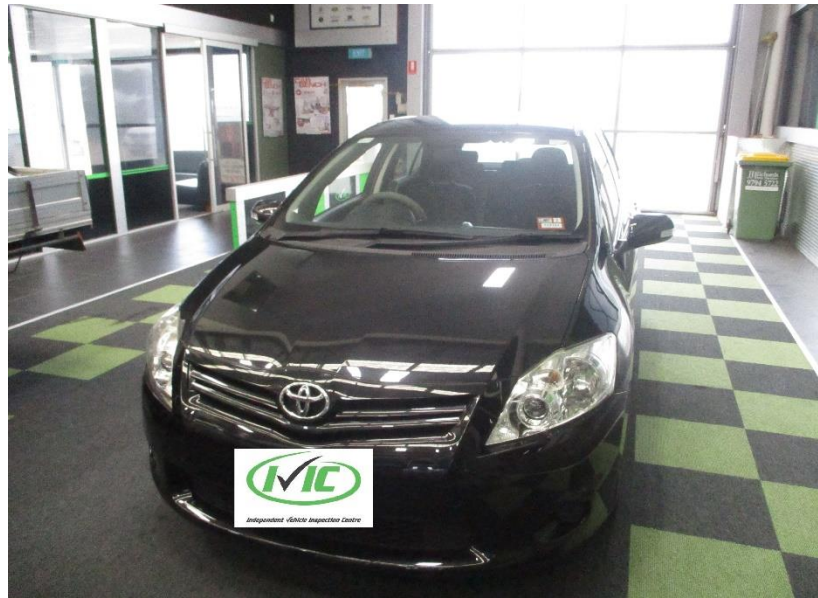
### Vehicle Image

"It is my expert opinion this vehicles accident damage is still existent and occupant safety is severely compromised in a potential 5<sup>th</sup> collision.

The has been an attempt to conceal a bent and kinked left rear chassis rail with underbody coatings, while further damage found to be a kinked left hand quarter panel dog leg. There are clear visual indicators of seam separation on the left quarter panel and water leaks associated with repair to the rear of the vehicle.

The measurement document indicates right rear chassis rail has 4 to 5 mm movement. There are endless defects throughout all previous insurance works conducted to this vehicle and rectification is not an option.

Furthermore, the collision energy management system built into this vehicle is currently altered and voided from the original Computer Aided Design (CAD) released by Toyota Motor Corporation"

- The vehicle had 51 repair defects.
- Manufacturer repair standards were not adhered to.
- Manufacturer repair methods were not followed.

- The insurer and the customer agreed to a settlement of \$ 12,000.
- The IVIC inspection fees, vehicle storage fees and customer rental vehicle costs were paid by the insurer.
- The vehicle was classified a "Write Off".
